FIRE FIGHTERS BEWARE

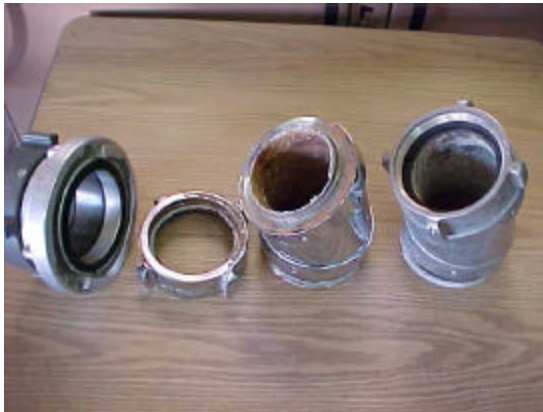
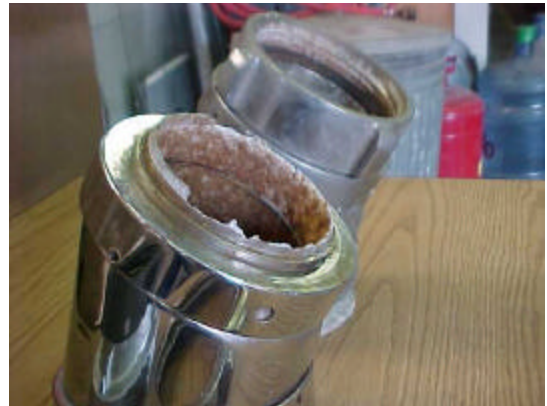
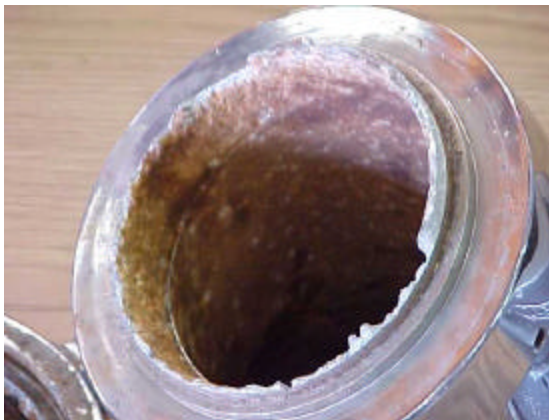
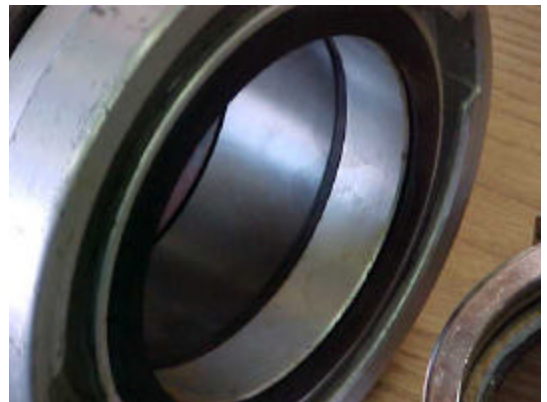
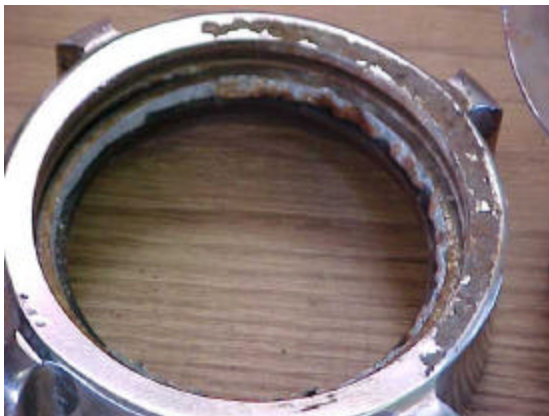
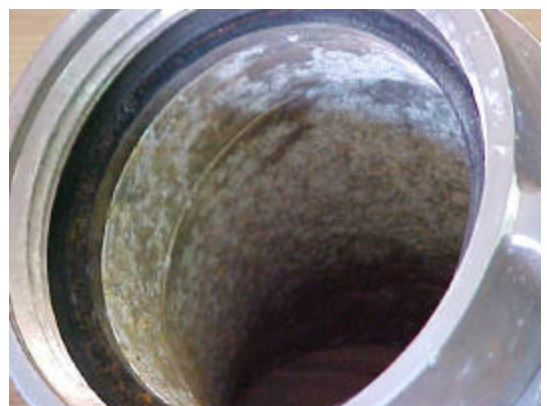
Failures of large diameter fittings and adapters have been happening all too often. A recent in plant incident of an intake of a 5" line on an engine struck a person in the head and almost killed them. Evaluating the broken ell revealed internal corrosion on the inside of the ell swivel joint where it was attached to the apparatus discharge. The ell had moderate corrosion as well. The ell's were installed in 1987 to accommodate 5" Storz connections. This again shows the need for caution when working around pressurized fire hose. Attached are the pictures showing both ell's and the Storz fitting that was attached.

The NFPA has a committee looking at the issue of adapters and hose fittings. Currently there is no standard that address these issues. There is no pressure rating that must pass. All of this is in the committee system. The new standard will require a minimum pressure rating of 900 psi test pressure with a working pressure of 300 psi.
